APOLLO 16 MISSION
ANOMALY REPORT NO. 10

REAR STEERING INOPERATIVE

APOLLO 16 MISSION

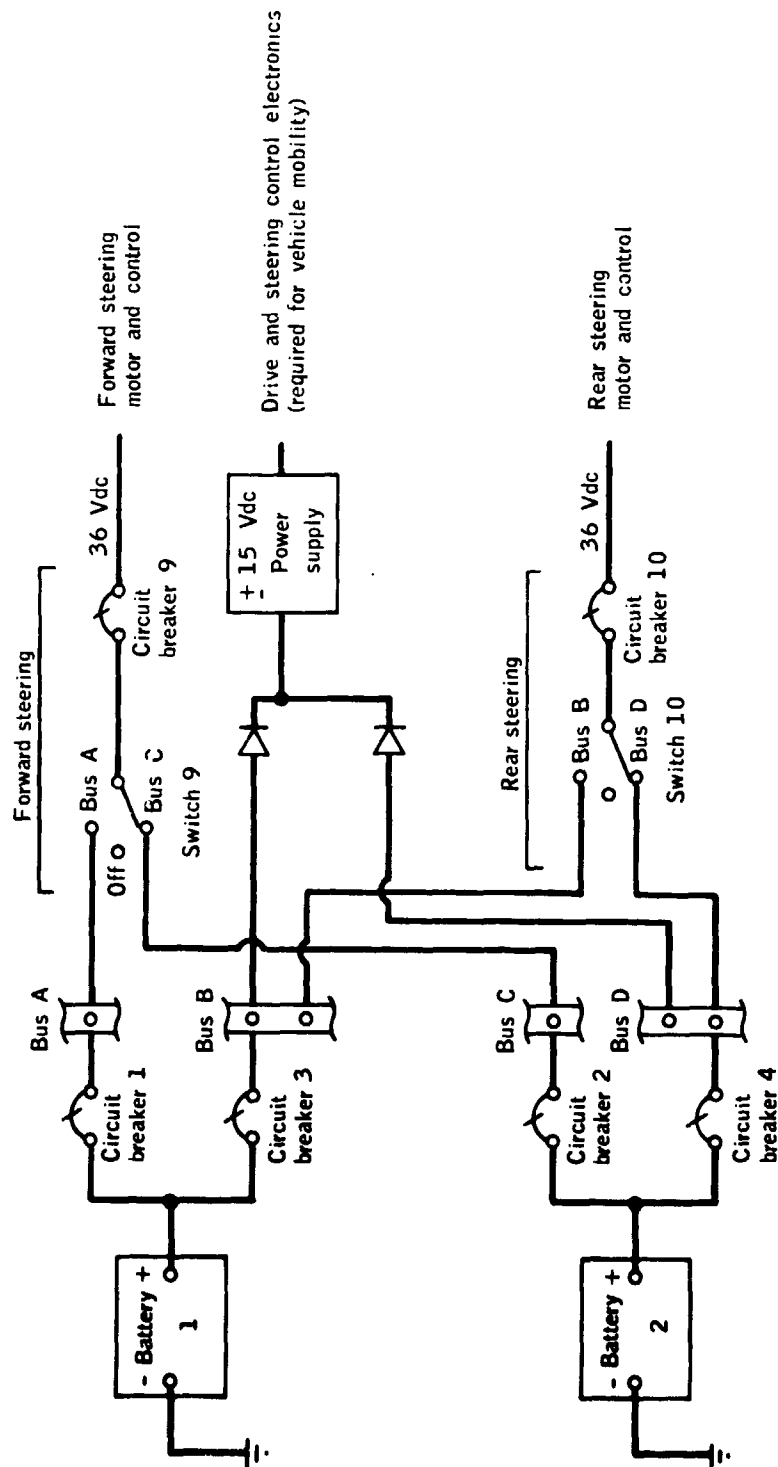
Figure 1.- Lunar roving vehicle steering power schematic.

Both the front and rear wheels of the lunar roving vehicle are steerable and are controlled by a hand controller. The driver can select front, rear, or both front and rear steering using switches located on the control and display panel. The rear steering system is powered when either circuit breaker 3 or 4 is closed, and circuit breaker 10 is closed with switch 10 positioned to the active bus (fig. 1).

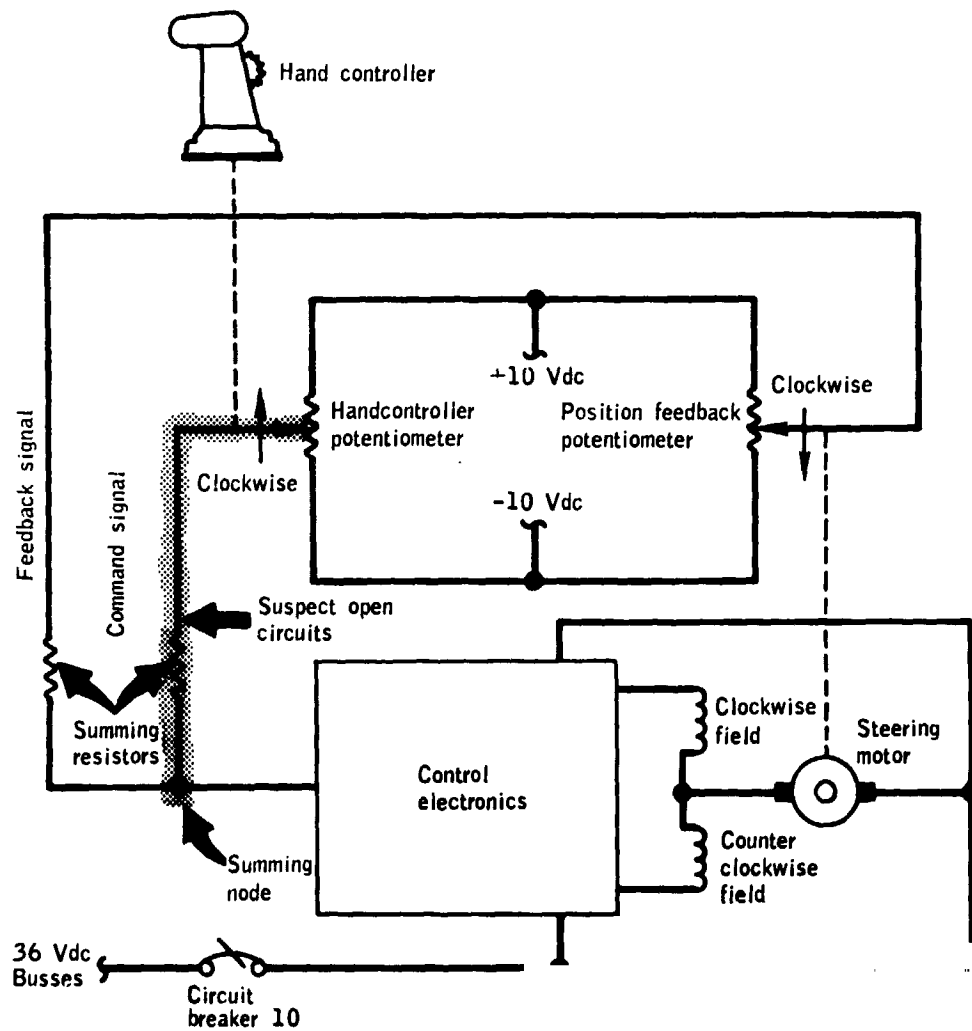
Figure 2.- Electrical steering system.

When the hand controller is positioned for a right turn, the hand controller potentiometer wiper is moved toward the positive end of the resistive element. The wiper voltage will increase (become more positive) as shown in figure 2. The summing node voltage will also increase, causing the control electronics to drive the steering motor clockwise until the wiper voltage from the position feedback potentiometer is equal but opposite in polarity to the hand controller potentiometer wiper voltage. At this point, the summing node voltage will be zero (the two voltages are added at the summing node) and the steering motor will stop. A similar sequence occurs for a left turn.

The only condition that will cause loss of steering and still keep the wheels centered during turns is an open circuit, either in the hand controller potentiometer or in the wiring between the potentiometer wiper and summing node (fig. 2).

The wiring, connectors, and summing resistor are all adequate. The only problem found was that the potentiometer wiper would open-circuit at temperatures below minus 58° C because the lubricant used in the potentiometer congealed. Thermal analysis, however, showed that neither lunar roving vehicle 1 or 2 reached temperatures below minus 5° C.

An open circuit must have occurred either in the hand controller potentiometer or between the potentiometer wiper and the summing node.

No corrective action was taken since the problem could not be further isolated and since the vehicle design and testing were considered adequate.
